Department of Toxic Substances Control

FACT SHEET, June 2005

DTSC Response Actions Continue at the BKK Landfills **Facility**

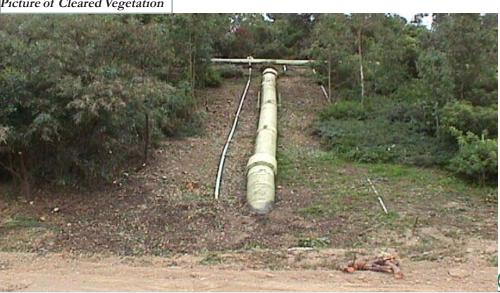
Picture of Cleared Vegetation

Maintenance of the 190-acre Class I (hazardous waste) landfill cap is very important. This several-foot thick cap contains all of the landfill waste and prevents migration of gases generated by degradation of the waste. One of the main tasks is to cut back overgrown vegetation to prevent interference with the cap's irrigation system. This several-mile long irrigation system keeps the cap from drying and cracking. Its pipes and sprinklers must also be constantly maintained in order to keep the cap moist.

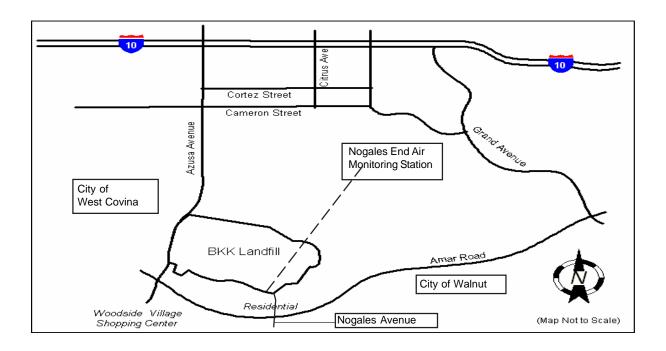
Additional landfill gas collection wells are being rehabilitated;

- Gas collection from the top of the Class I landfill is being increased;
- Storm drain inlets are being checked and sealed to prevent any gas migration from these areas: and
- The entire top and south side of the Class I landfill are being closely evaluated with gas detection instruments to identify specific sources of gas emissions that can then be repaired.
